**TRANSPORTATION SCIENCES CENTER  
ACCIDENT RESEARCH GROUP**

**Calspan SRL Corporation  
Buffalo, NY 14225**

**CALSPAN ON-SITE SEAT BELT FAILURE INVESTIGATION  
CALSPAN CASE NO. 94-41  
VEHICLE: 1992 GEO METRO CONVERTIBLE  
LOCATION: SOUTH CAROLINA  
CRASH DATE: [REDACTED] 1994**

**Contract No. DTNH22-94-D-07058**

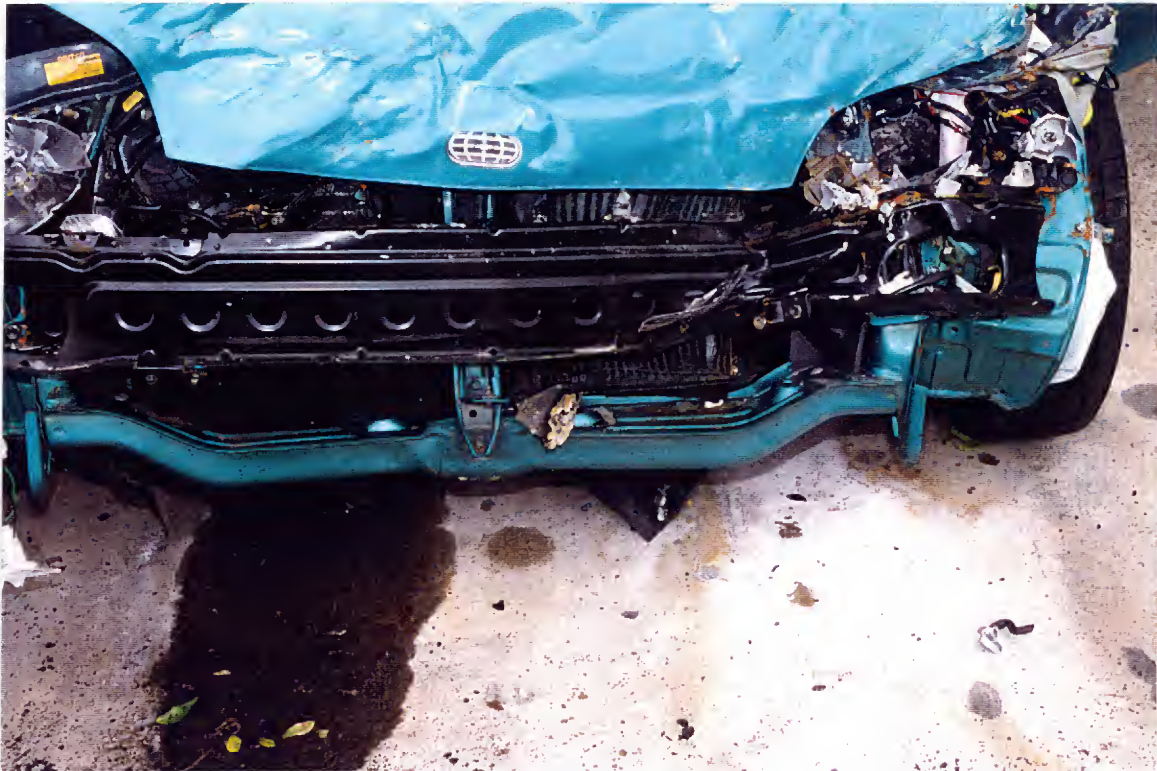
The 1992 Geo Metro sustained moderately severe frontal damage as a result of its front-to-side impact sequence with the Ford Explorer (vehicle #2). The damaged area involved the entire frontal width of the vehicle which included the bumper assembly, grille, hood, both front fenders, and the substructure of the Geo. The impact separated the bumper fascia and the styro-foam filler panel from the bumper reinforcement bar (refer to Photograph Nos. 9 and 10). The direct contact damage was 135.9 cm (53.5") which extended across the full frontal width of the separated fascia. Maximum frontal crush was 43.5 cm (17.1") located 34.3 cm (13.5") inboard of the left front corner of the bumper reinforcement bar (refer to Photograph Nos. 11 through 14). A crush profile was documented at the bumper reinforcement bar which resulted in a measurement damage length (Field L) of 126.7 cm (49.9"). The crush profile was as follows:  $C_1=42.2$  cm (16.6"),  $C_2=42.9$  cm (16.9"),  $C_3=33.7$  cm (13.25"),  $C_4=27.0$  cm (10.6"),  $C_5=23.8$  cm (9.4"),  $C_6=26.0$  cm (10.25"). These values represent the actual residual crush profile with the free space (bumper contour and filler depth) deducted from the field measurements.

1. Close-up view of the frontal damage to the Geo Metro.

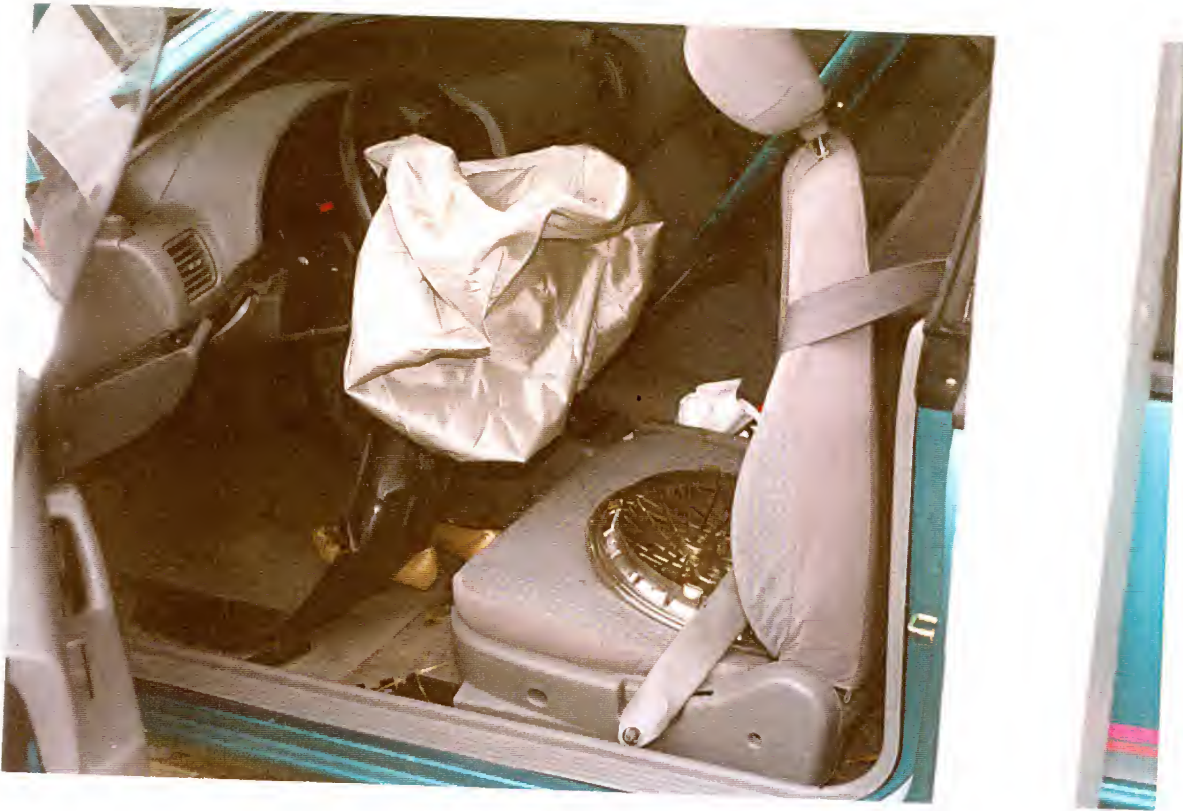
3. Overall interior view of the deployed air bag, deformed seat back, and the separated lower belt anchorage.

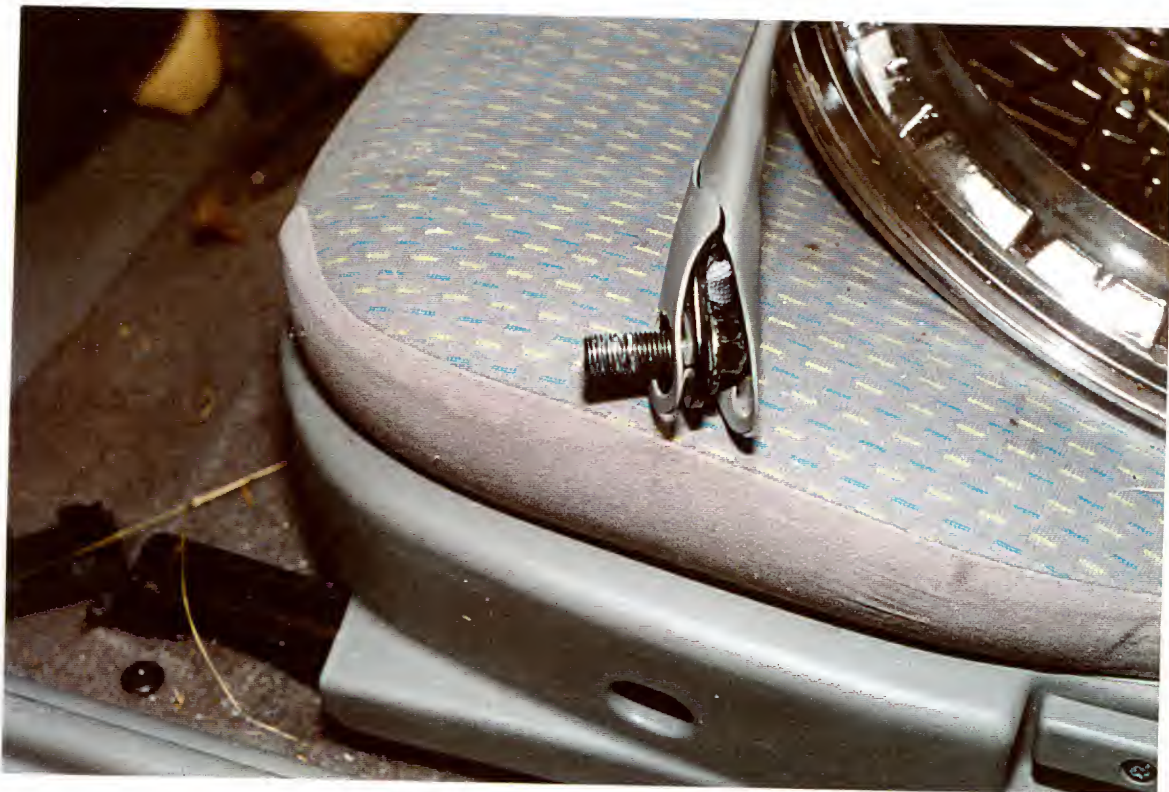
Notification of the crash and the subsequent inspection of the Geo Metro occurred approximately 2 months following the crash. At the time of our inspection, the lower anchorage for the left front seat belt system was found disassembled with the bolt and washer lying on the floor behind the driver's seat. The county coroner and the investigating officer observed the belt system in this condition during a post-crash inspection of the vehicle, which followed the death of the driver.

4. Close-up view of the lower anchorage and bolt assembly.

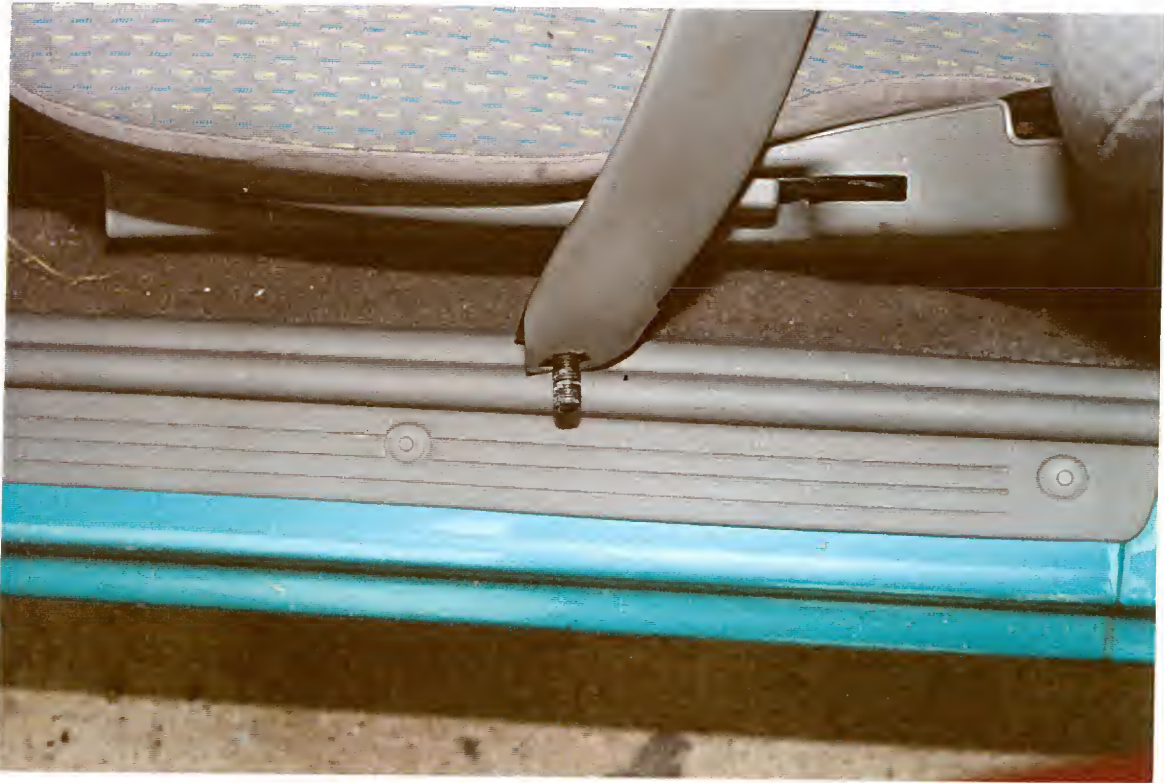
5. Additional view of the separated lower anchorage assembly.

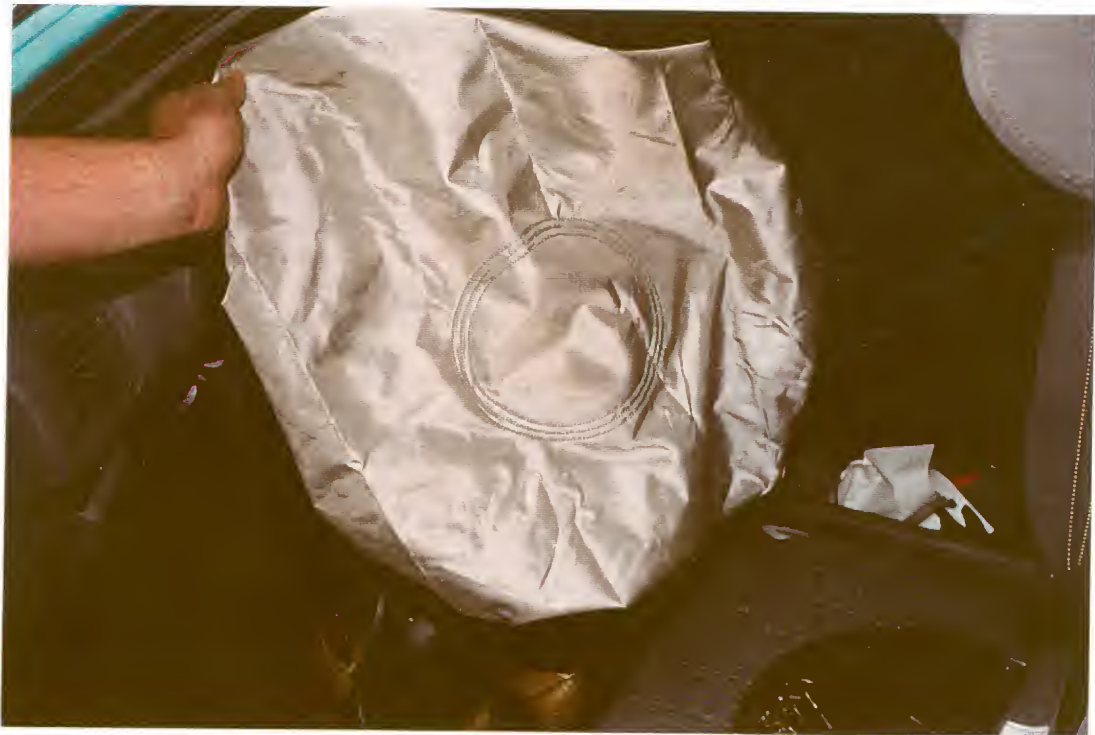
8. Make-up transfers on the deployed driver's side air bag.

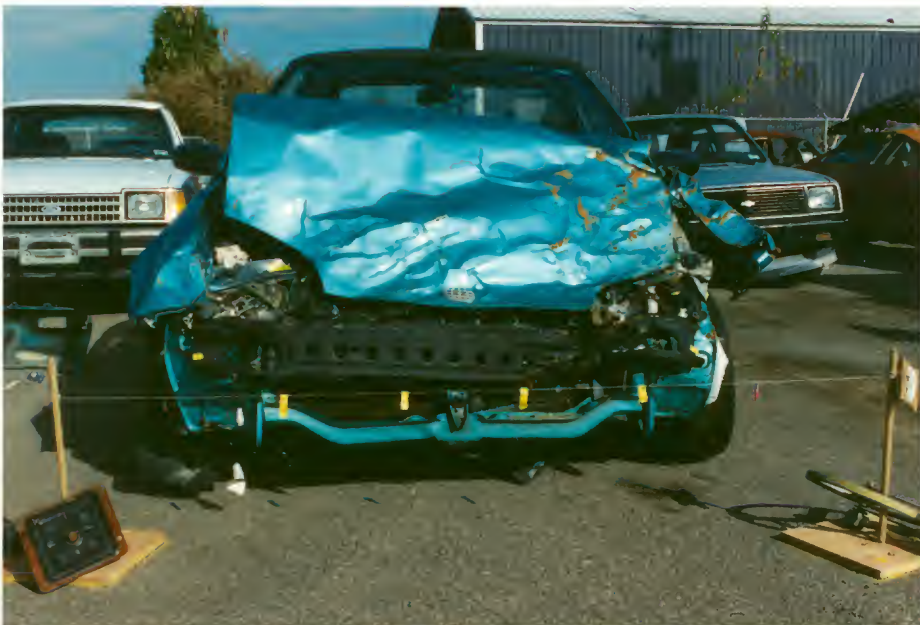
8. Frontal damage to the Geo Metro.

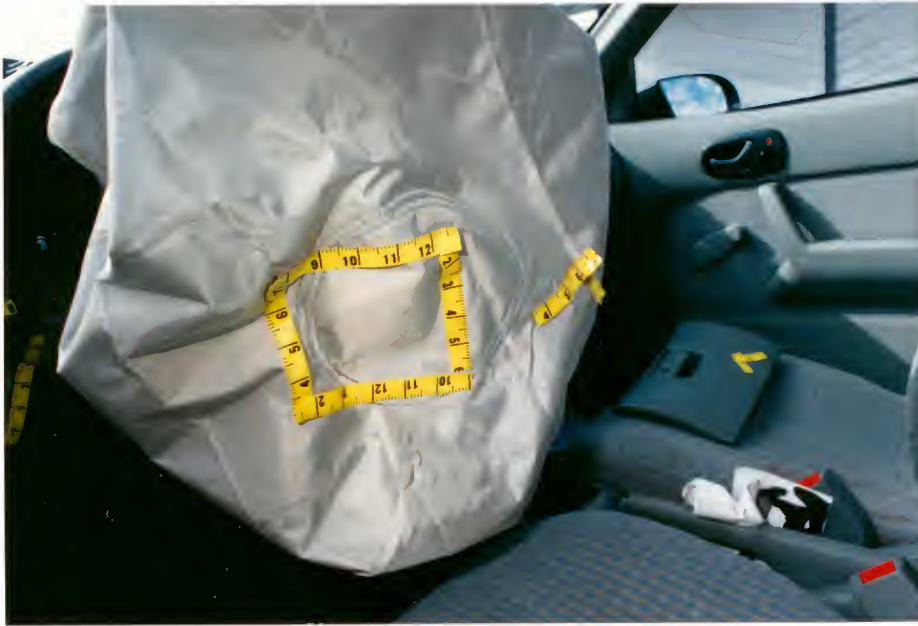
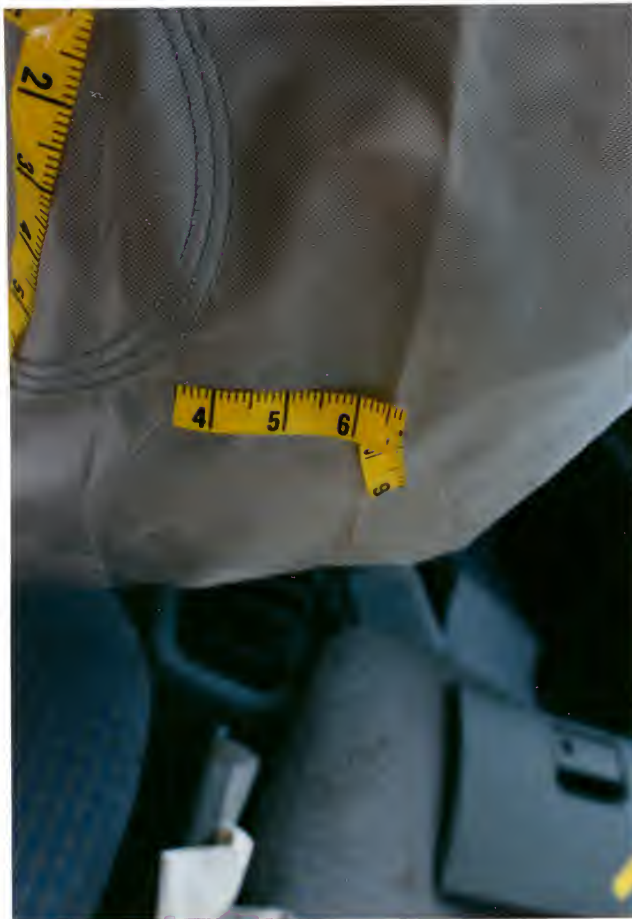
The driver's face contacted the deployed driver's side air bag. Facial contact was evidenced by make-up and lipstick transfers on the bag. A fleshtone make-up transfer was located on the air bag tether reinforcement at 0-6.4 cm (0-2.5") below the horizontal centerline and 1.3 cm (0.5") left to 5.7 cm (2.25") right of the vertical centerline. A faint pink-colored lipstick transfer was noted to the bag at the right upper quadrant, located 10.2-14.0 cm (4.0-5.5") above the horizontal centerline and 9.5-10.2 cm (3.75-4.0") right of the vertical centerline (refer to Photograph Nos. 23 and 24).

23. Close-up view of the driver's side air bag.

24. Lipstick transfer mark on right upper quadrant of air bag.

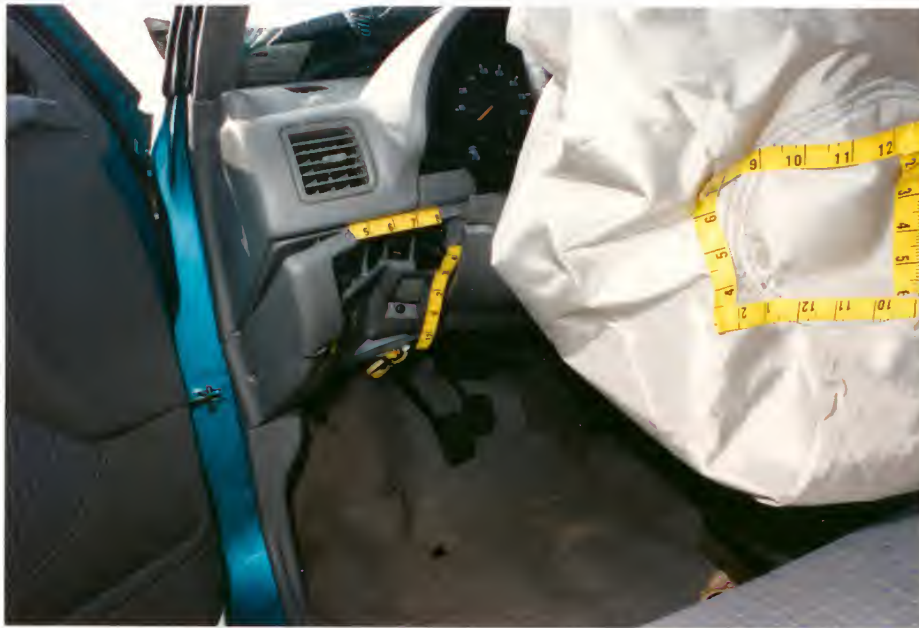
The driver's left knee impacted the mid and lower instrument panel 48.3-61.0 cm (19.0-24.0") left of center and 22.9-38.1 cm (9.0-15.0") below the upper instrument panel. The contact fractured the plastic mid panel and displaced the speaker cover and hood release mechanism approximately 7.6 cm (3.0") forward (refer to Photograph No. 27). The driver's right knee contacted the knee bolster at the base of the steering column (refer to Photograph No. 28). This contact deformed the plastic component and cracked the leading edge of the bolster. In addition, blue denim fabric transfers were present in the in the area of contact which was located 28.0-40.6 cm (11.0-16.0") left of center and 35.6-38.1 cm (14.0-15.0") below the top of the instrument panel.

26. Left knee impact to the left mid instrument panel.

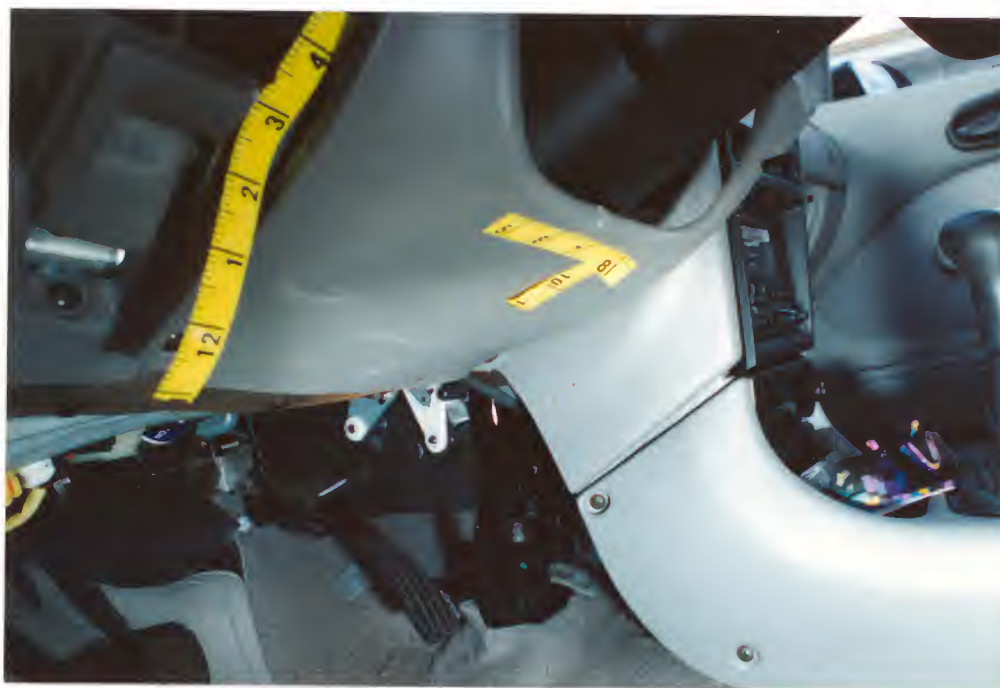
28. Right knee contact to the base of the steering column cover.

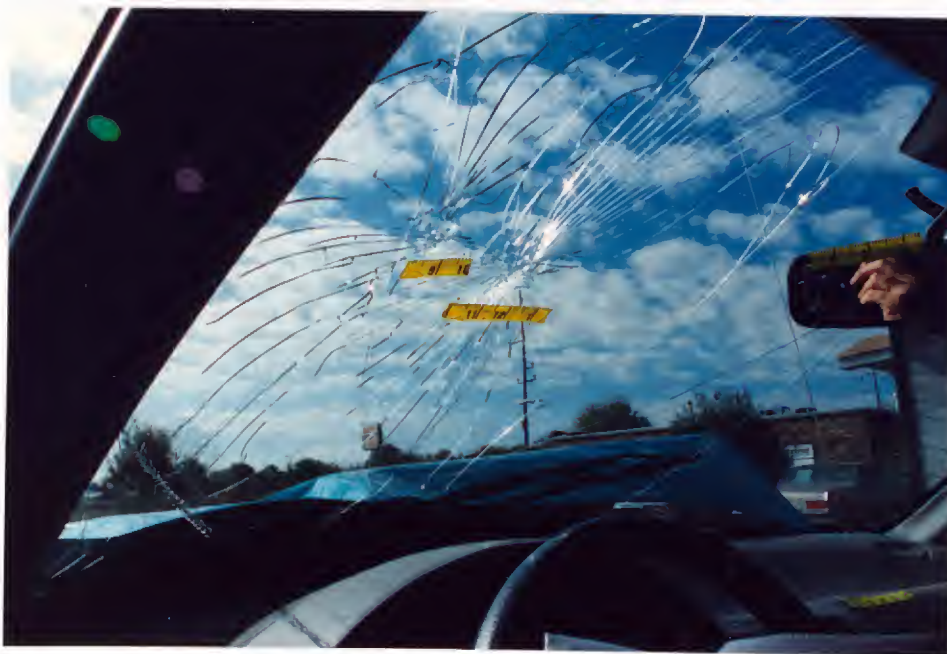
Although the exterior deformation was rated as moderately severe for the sub-compact vehicle, there was no interior intrusion or damage associated with the exterior deformation. The windshield was cracked as a result of the exterior deformation and subsequent impact from the driver's left hand and wrist (refer to Photograph No. 29). Two distinct contact points were noted to the windshield. The driver's left hand contacted and cracked the laminated windshield 30.5 cm (12.0") left of center and 22.2 cm (8.75") below the header while her wrist cracked the glazing 38.1 cm (15.0") left of center and 20.3 cm (8.0") below the header. These contact points resulted from hand displacement from the steering wheel rim as the air bag expanded against her anterior forearms.

29. Interior view of the driver's side windshield damage.

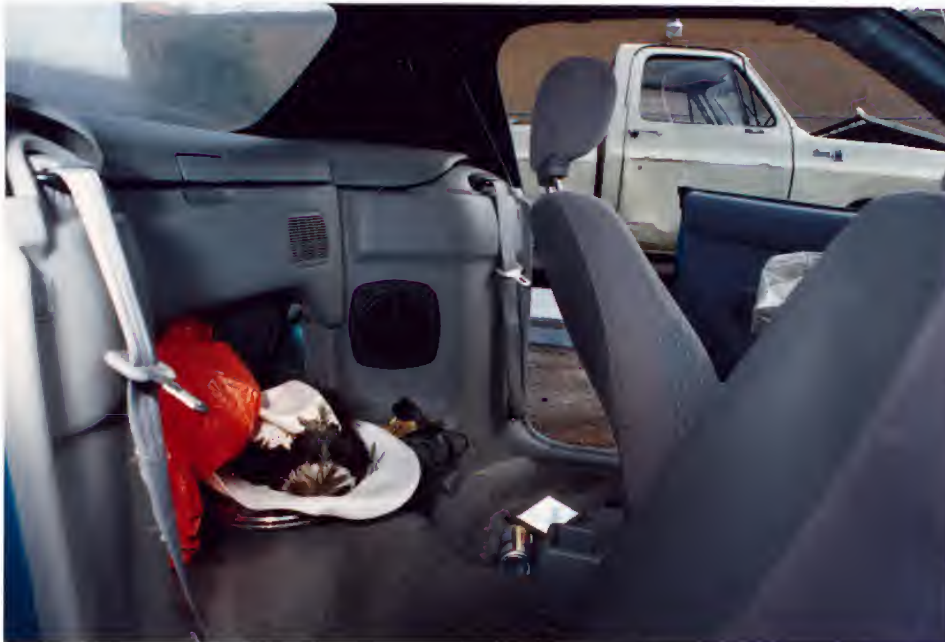
The child occupants positioned in the cargo area of the vehicle, rearward of the front bucket seats, initiated a forward trajectory and loaded the left front seat back, deforming the seat back frame in a counterclockwise direction (refer to Photograph No. 30). One of the child occupants continued forward between the front seat back supports and impacted the padded right upper instrument panel, deforming the panel 22.9-31.8 cm (9.0-12.5") right of the center and 0-10.2 cm (0-4.0") below the top surface of the instrument panel (refer to Photograph No. 44). A scuff mark was noted to the glove box door 3.8-7.0 cm (1.5-2.75") right of the door center and 13.3-16.5 cm (5.25-6.5") below the top of the door. At the time of vehicle inspection, the glove box door was found on the right front floor completely separated from the vehicle as documented in Photograph No. 43.

30. Right side view of the rear storage area behind the front seats and the deformation to the back of the left front seat back.

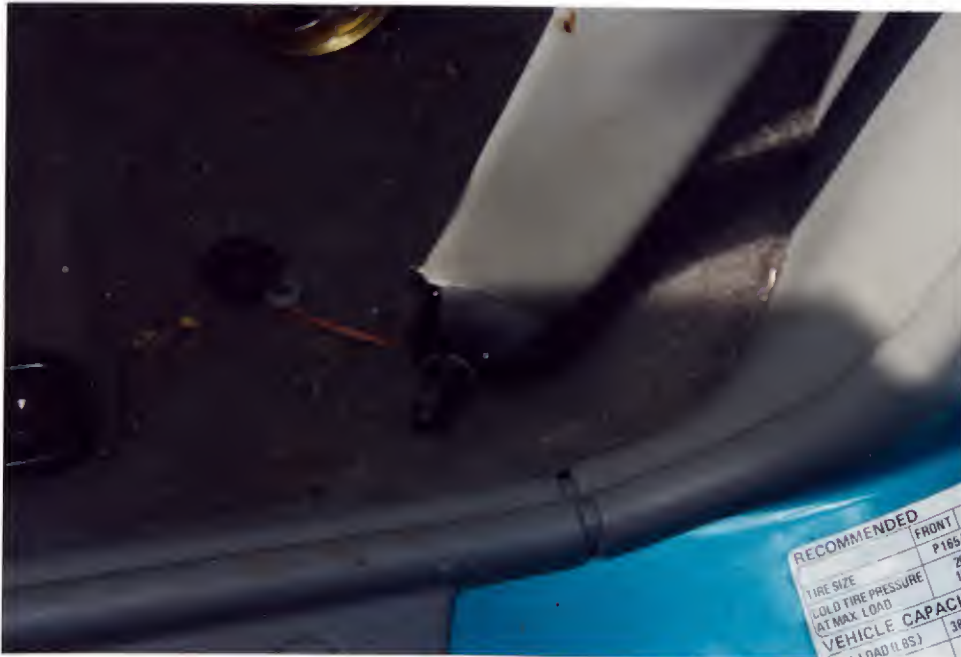
At the time of our inspection, the lower anchorage for the left front belt system was disassembled with the bolt and washer lying on the rear floor area of the vehicle. The coroner noted that she found the components in this disassembled state when she and the investigating police officer inspected the vehicle following the death of the driver.

32. View from left side of the driver side lap belt separated from lower anchor point at sill.

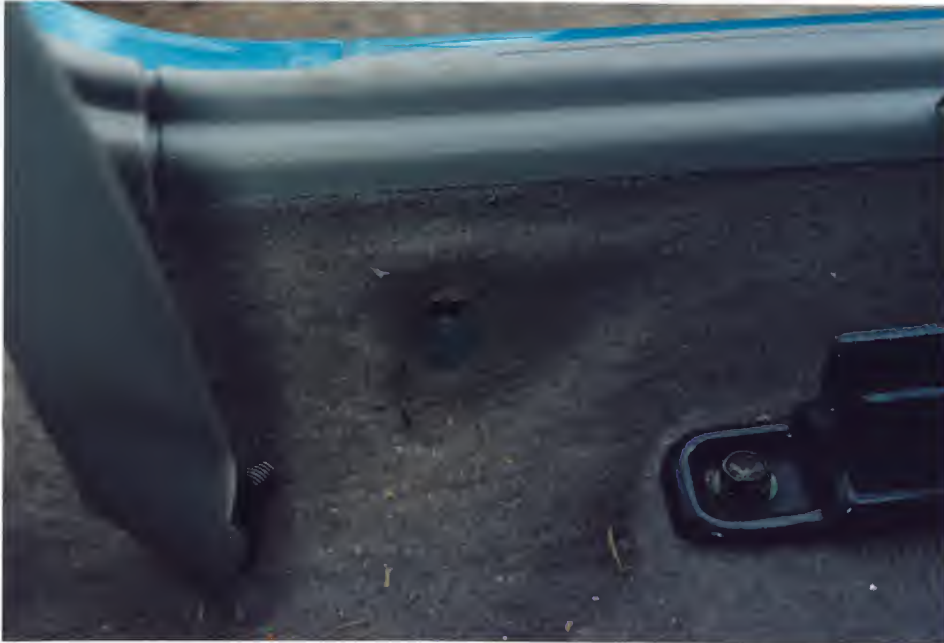
The belt system anchor bolt was threaded into the vertical surface of the sill between the B-pillar and the rear seat track anchorage (refer to Photograph No. 33). The steel sill was reinforced at the location of the bored hole and threaded for the bolt. The edges of the threads in the sill were polished and flattened. It should be noted that the threads within the sill did not appear to be stripped from possible cross threading or over torquing of the bolt.

In the event that the threads were damaged during the assembly process of the vehicle, or that an improper sized bolt or tap was used to thread the hole, normal movement of the belt system through routine usage and access to the cargo area could have backed the bolt out toward the end of the threads, thus separating under occupant loading during the crash. The threaded ends of the bolt and bore did not exhibit a flattening to the end of the threads that would occur from a force applied perpendicular to the bolt length prior to separation (refer to Photograph Nos. 33-40).

33. View from inside of driver seat belt separated from sill.

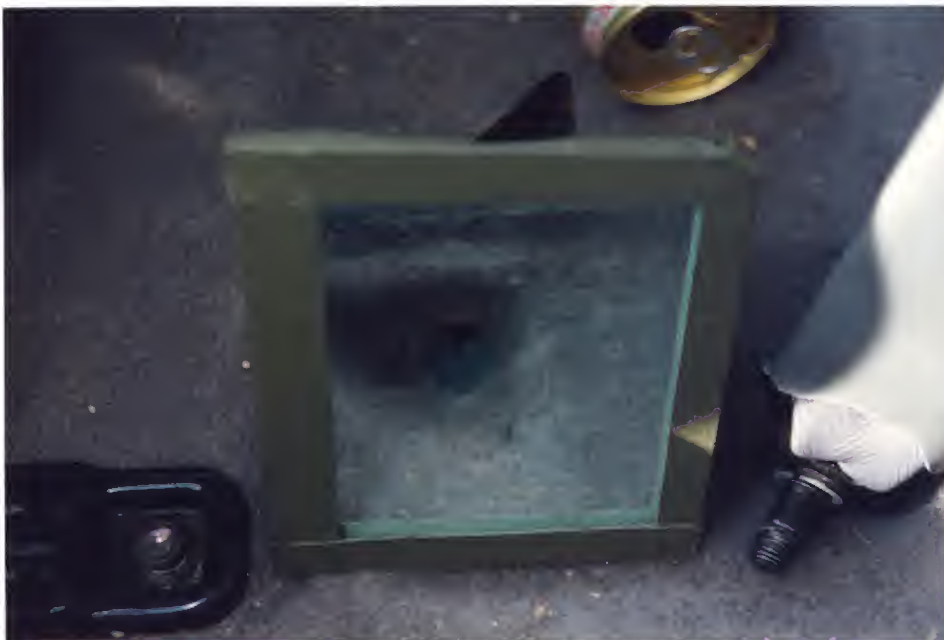
34. Seat belt with anchor bolt (mirror view) and the floor anchorage hole.

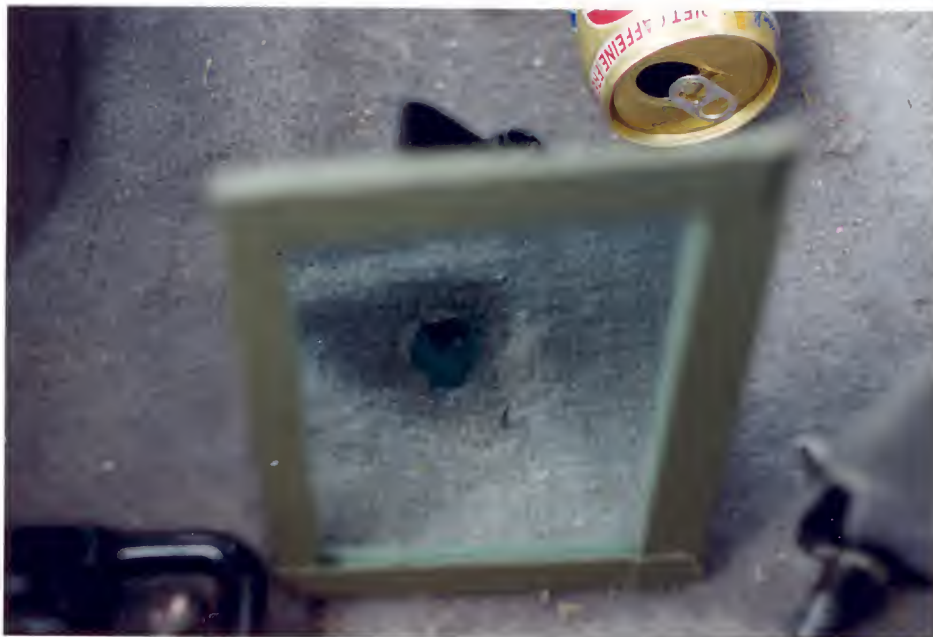
35. View of the floor anchorage hole.

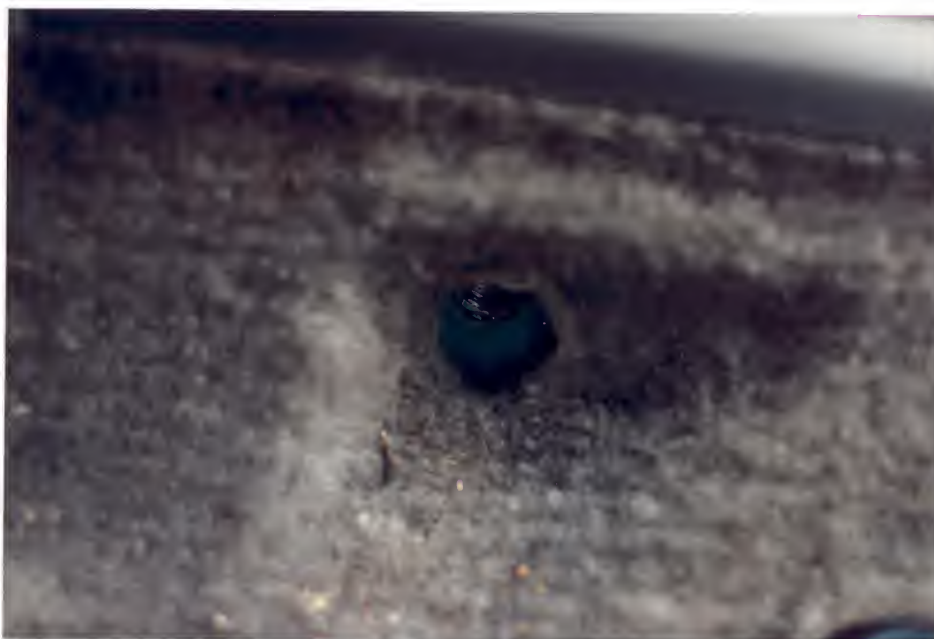
During the on-site investigation, this investigator attempted to re-thread the bolt into the sill. Although the bolt engaged the threads and turned into the sill, the threaded fitment would not securely hold the bolt into the sill. The bolt could be extracted from the sill without rotating the bolt in a counterclockwise direction. A slight side-to-side movement with a pull force parallel to the length of the bolt would separate the bolt from the sill, indicating the bolt was improperly sized for the threaded fitment.

36. Close up view of the stripped threads in the floor anchorage hole.

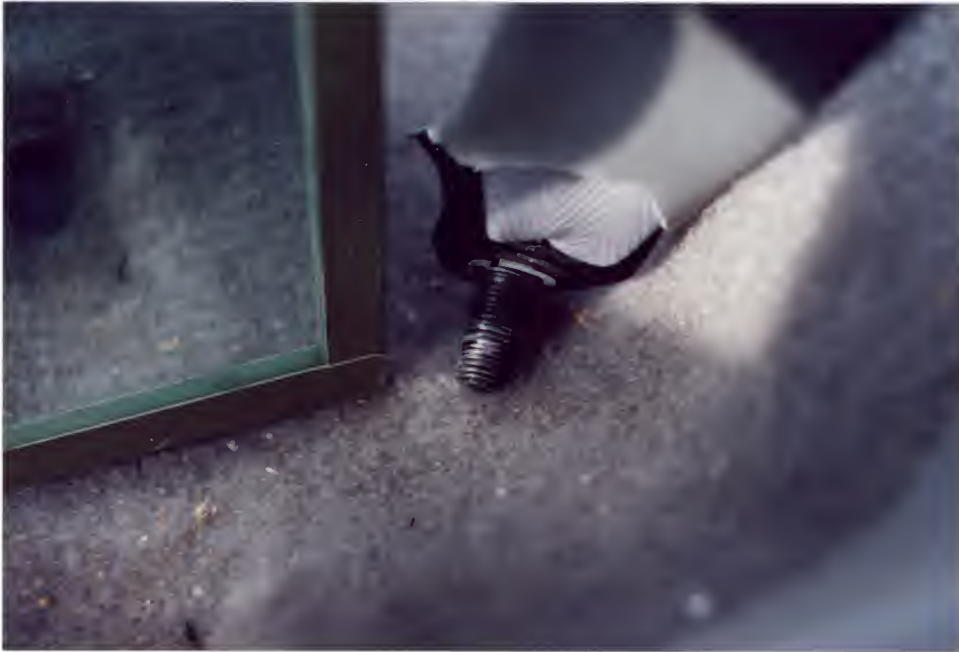
37. Back side view of seat belt anchor bolt in plastic jacket.

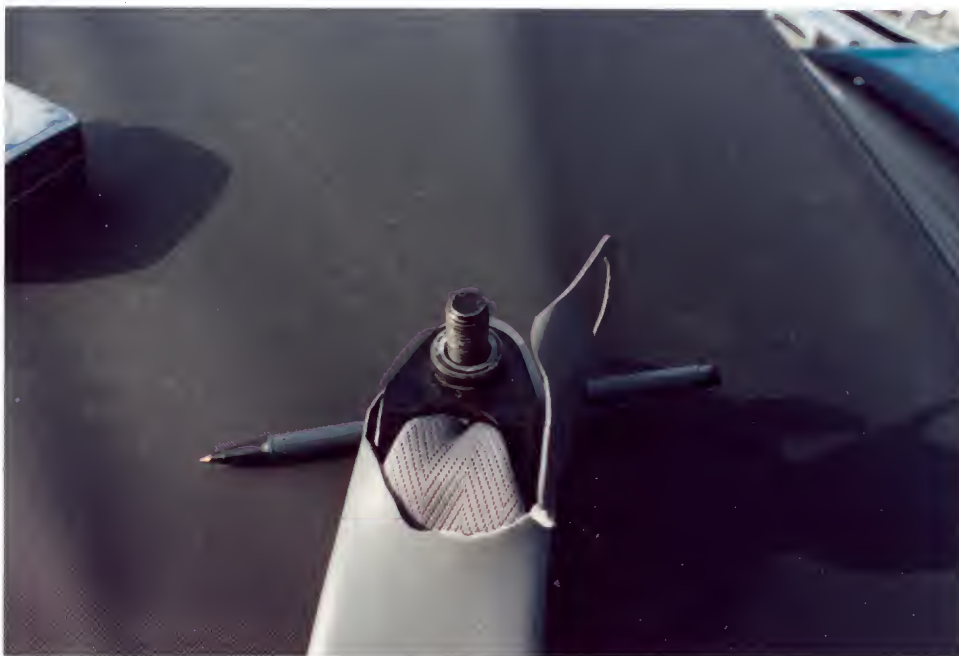
38. Close up view of damage to anchor bolt plastic jacket.

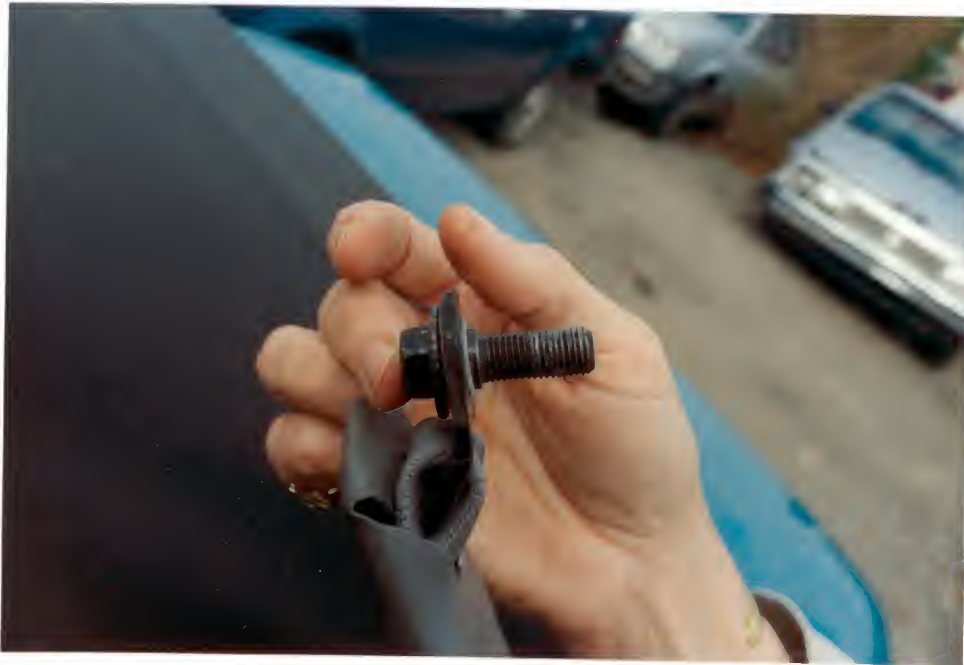
39. Perpendicular view of lower seat belt and anchor bolt assembly.

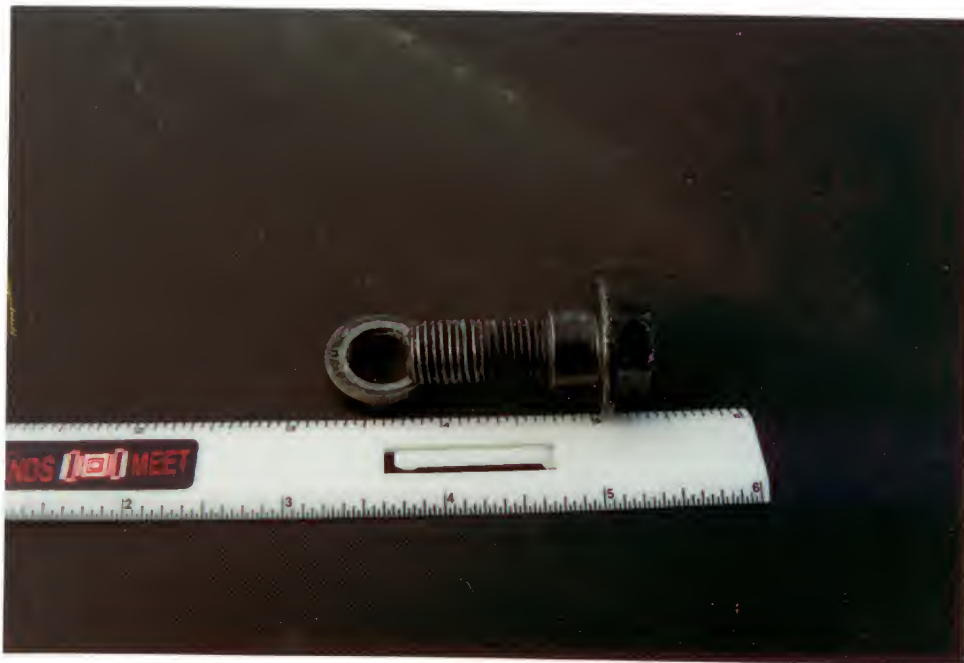
The anchor bolt was 30.0 mm (1.2") in length and 10.3 mm (13/32") in diameter. The head of the bolt was stamped with grade classification E2 75 and was backed with a 20.6 mm (13/16") outside diameter washer with a thickness of 4.8 mm (3/16"). The threads of the bolt were not damaged, however, the lower segment of the threads were covered with a whitish substance, probably a thread lubricant or lock compound. The bolt was threaded into a reinforced segment of the vertical aspect of the sill, forward of the base of the B-pillar. The edges of these threads were polished and flattened, however, the threads did not appear to be stripped from cross threading or over torquing of the bolt.

40. Hex head anchor bolt with washer.

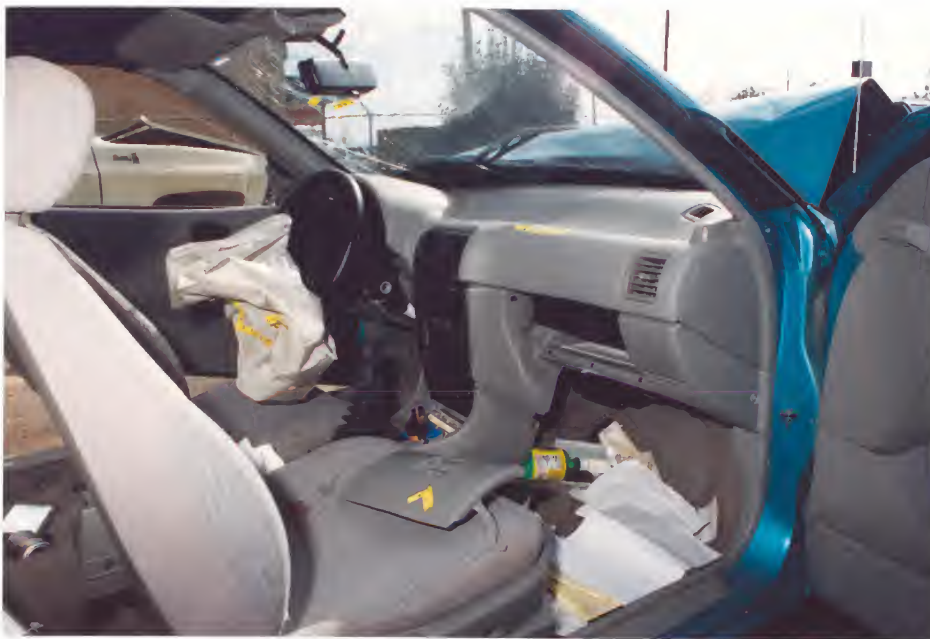
43. Perpendicular view across the interior of passenger side.

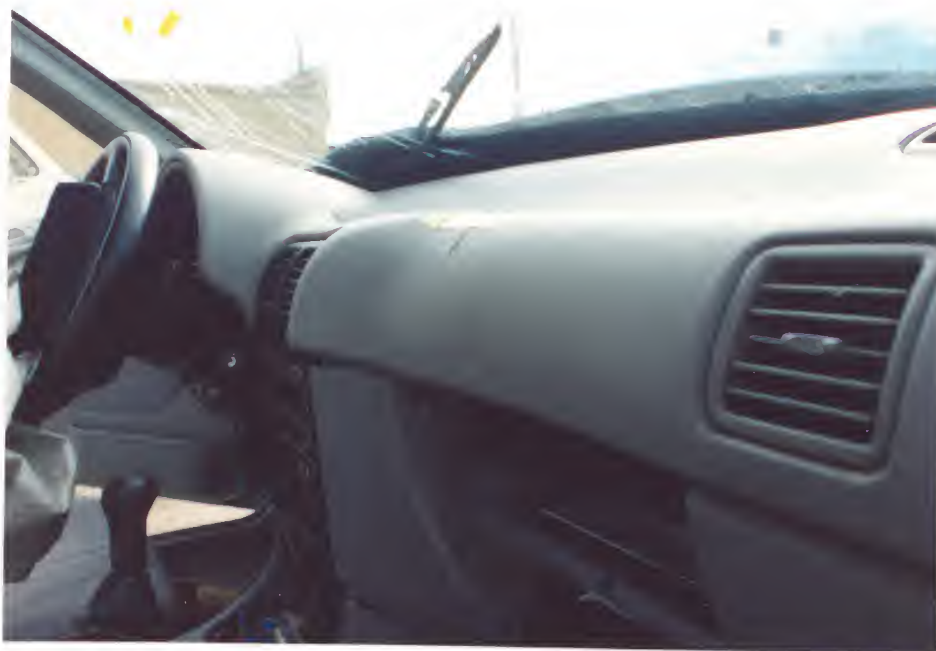
44. Child passenger contact to the right upper instrument panel.

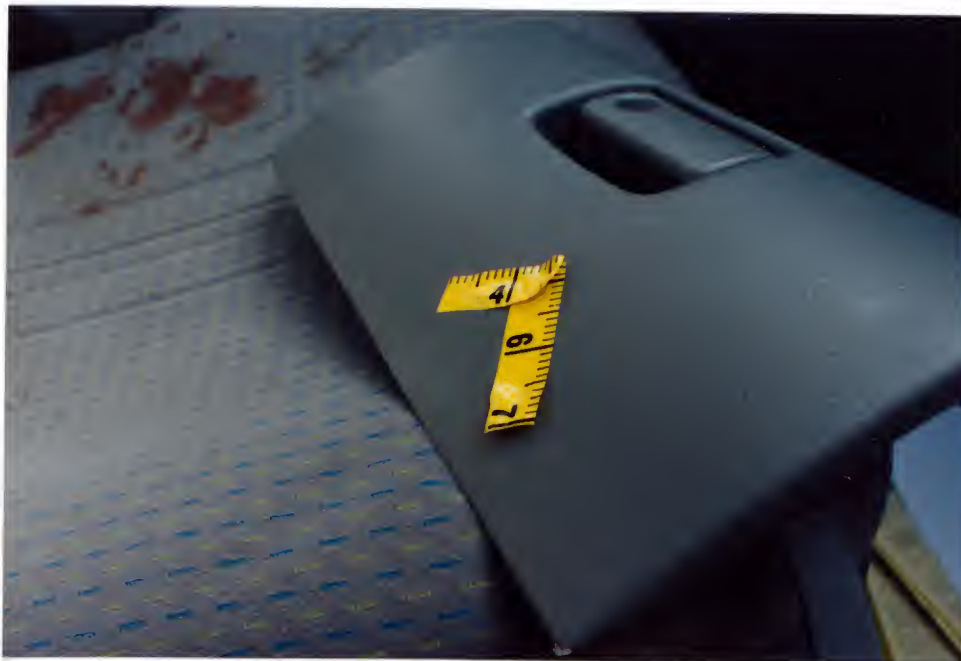
46. Probable child passenger knee scuff on the glove box door.
